## CASE STUDY

# Level One State of Cleanliness of a Treatment Settler

Chemical Degassing was performed on a high-temperature froth treatment settler. Residual sludge up to a foot along the walls, seams were completely removed for a Class 1 inspection.

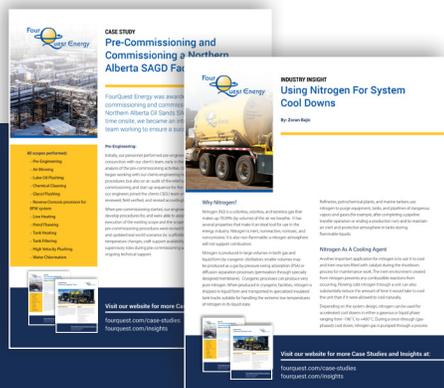
Following chemical injection for a total period of 13 hours, the steam was shut off and the settler allowed to cool to ambient temperature, before purging with Nitrogen once more and allowing inspection crews to enter without supplied air. The result was a spotless vessel, the cleanest the client had ever seen it during maintenance.

With the settler successfully drained, the vessel was preheated to 90 °C using steam. Our specialty chemistry **FQE Solvent H**, designed to dissolve heavy hydrocarbons quickly, was then injected into a steam stream to clean the inside of the settler vessel. The exiting waste effluent was then easily disposed into the client's hydrocarbon drain system. As a final step, **FQE LEL** and **FQE LEL-V Eco** was used to remove residual LELs.
